Vibration Analysis

Bearing fault 200 HP Electric motor

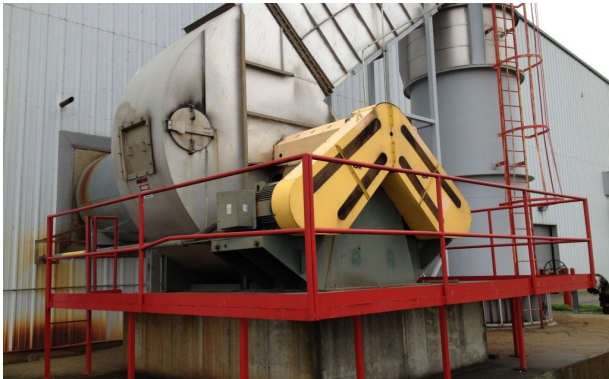
Bearing was in service for 10+ years, sudden change in high frequency vibration data

Lubrication was added and data was collected the next day, little to no change after lubrication

Three weeks later the bearing audible noise made a large increase, bearing was replaced
